The Command System Malfunction of the *Telstar* Satellite

By J. S. MAYO, H. MANN, F. J. WITT, D. S. PECK,
H. K. GUMMEL and W. L. BROWN

Loss of the command function of the Telstar satellite first occurred on November 24, 1962. There had been earlier indications of degraded performance. Facts are presented which led to the conclusion that the malfunction of the command system was due to surface damage to certain transistors in the redundant command decoders by the enhanced radiation in the inner Van Allen belt.

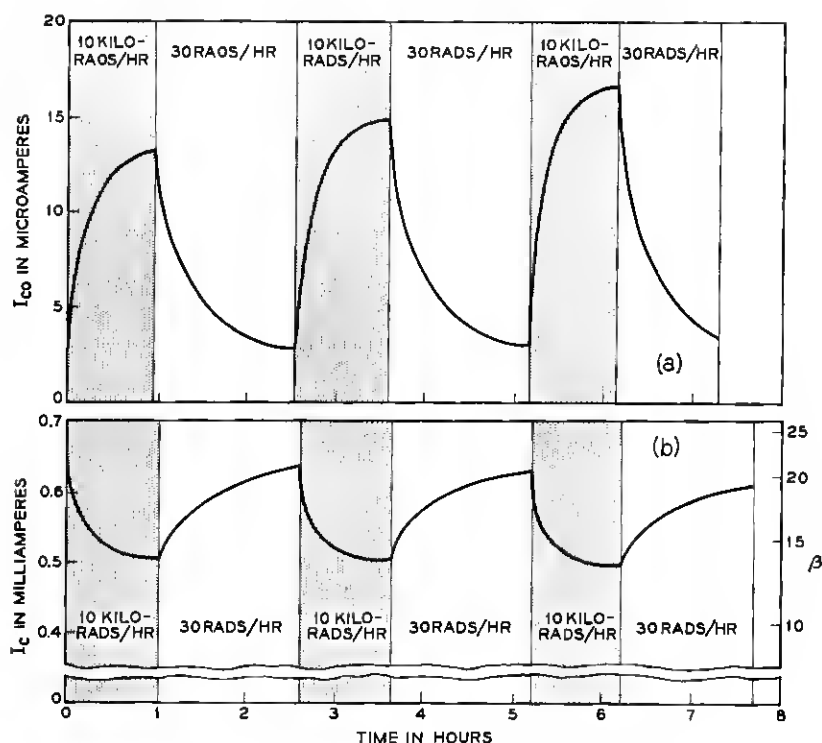
Fig. 4 — Leakage current and gain of a transistor cycled between high and low radiation field intensities.

(i) Those units which were heavily degraded in the high-intensity field partially recovered in the low-intensity field. The time constant for I_{CBO} and h_{FE} degradation ranged from 1 to 20 minutes; recovery has logarithmic time dependence. Typical cycles are shown in Fig. 4 for a transistor which had been pre-irradiated to degrade I_{CBO} from a few nanoamperes to several microamperes.

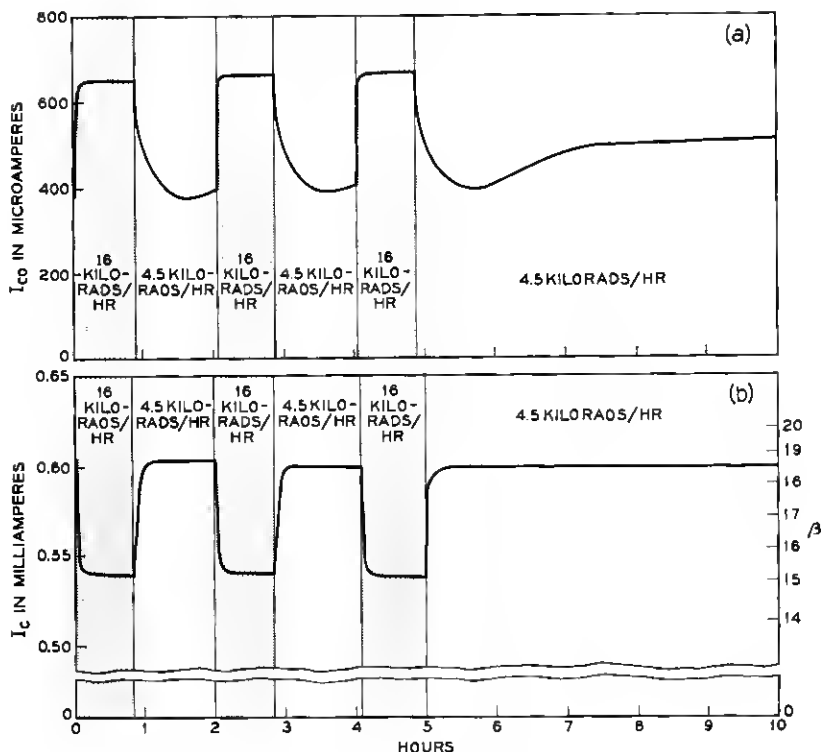
Fig. 5 — Leakage current and gain of a transistor cycled between two high radiation field intensities.

(ii) Short-term reciprocity does not hold; i.e., during cycling tests it was apparent that a given total dose applied at a fast rate caused more degradation than the same dose applied at a slower rate. Note from Fig. 5 that 3.6 hours at 4.5 kilorads per hour induce less effect than 1 hour at 16 kilorads per hour, although the total dose is the same for both cases.

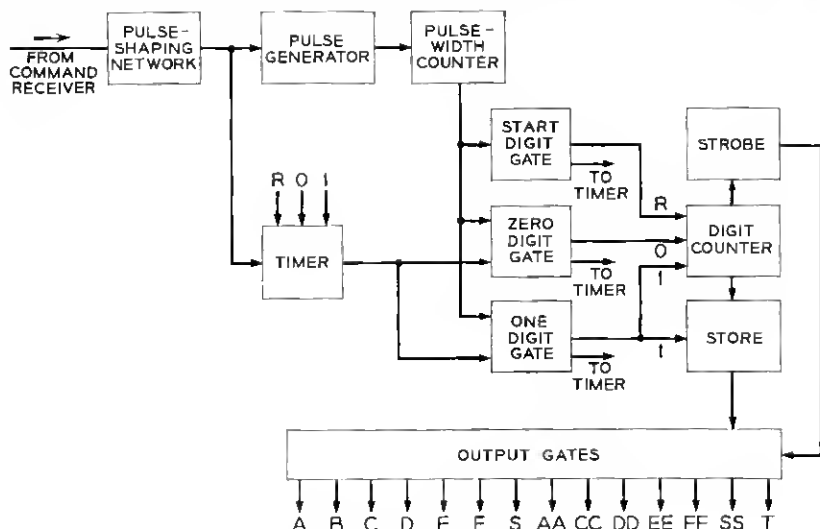
Fig. 6 — Command decoder block diagram.

If the gain of the zero digit gate transistor becomes sufficiently low in value, that stage will not be capable of driving the digit counter. As one sees from Fig. 6, the zero digit gate drives the digit counter and the timer; the one digit gate drives the digit counter, and, after a small amount of delay, drives the store. The scheme for circumventing the failed zero digit gate is to send in place of a "zero" a modified "one" code in such a way that the one digit gate is turned on and almost immediately turned off again. By use of the notched and shortened pulse in Fig. 9(e), it is possible to advance the digit counter but not to build up sufficient voltage to set a "one" into the store. Thus this notched "one" causes the same response in the digit counter and store as a "zero." Unfortunately, the notched "one" does not fully enable the timer circuit, and it is difficult to handle codes containing three sequential "zeros," unless these "zeros" are at the end of the code.*

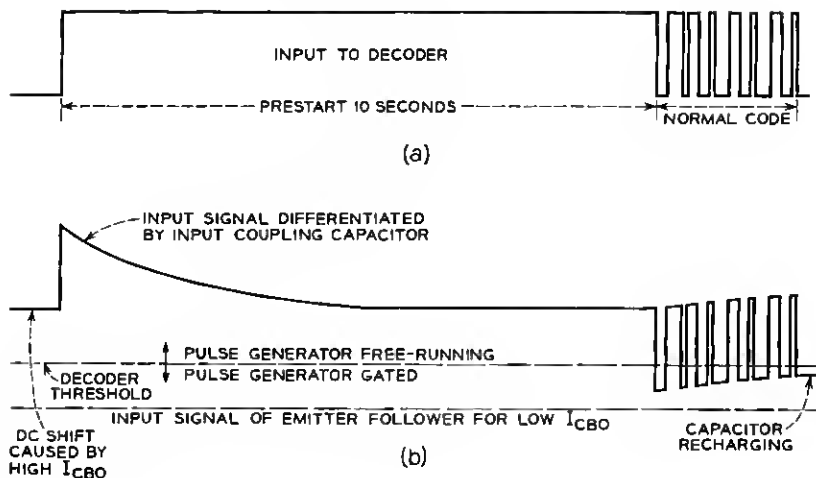
Fig. 7 — Modified command for high I_{CBO} in pulse shaping network first stage.

This circuit is an emitter follower with a high V_{CE} ; high I_{CBO} (>25 microamperes) will force the base voltage of this stage above a threshold level and will consequently cause the pulse generator to free-run. The input of the emitter follower is coupled to the output of the command

receiver through a capacitor. By preceding a normal command signal by a long pulse, as shown in Fig. 7(a), the input capacitor is charged to the full pulse amplitude level. When the pulse is removed, the charged capacitor will serve to pull the base of the emitter follower below the threshold level so that a command may be transmitted during the interval that the capacitor is being discharged by the leakage current (see Fig. 7b).

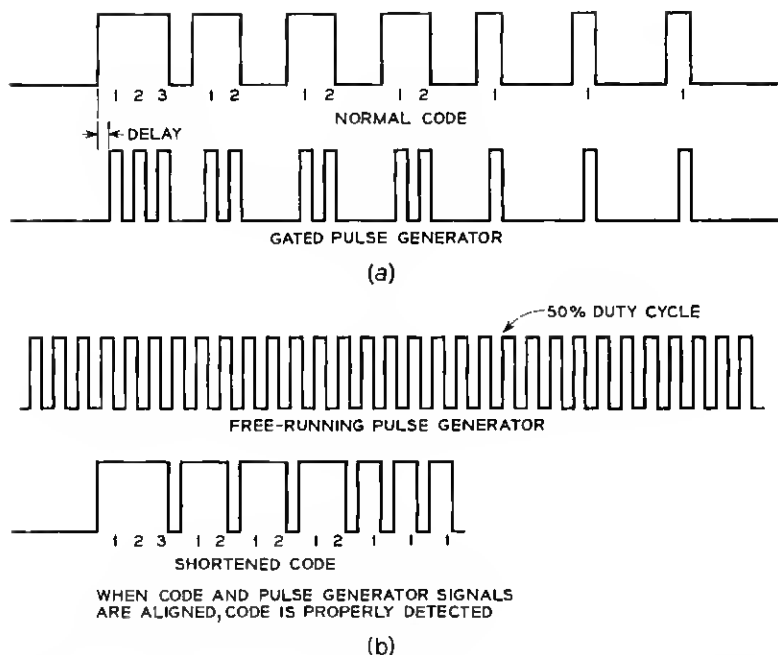
Fig. 8 — Modified command for high I_{CBO} in pulse shaping network second stage.

If the leakage current of this stage is above 150 microamperes, the pulse generator will free-run. Leakage currents in excess of 300 microamperes will cause the digit gates to be held off; consequently, the modified command signal described here will be effective only for a leakage current below 300 microamperes. Normally, the pulse generator, a gated astable circuit, is allowed to free-run only when an input pulse is present, as shown in Fig. 8(a). The modified command consists of a near-standard command set up on a shorter time interval basis, so that the input pulses are occasionally "in phase" with the free-running astable circuit, as shown in Fig. 8(b). With the shortened code it is possible to cause spurious decoder response when proper phasing does not exist. Errors can be avoided if the command pulse sequence is very carefully established.
